Enhanced Preliminary Assessment Report:

Elrama Army Housing Units
Elrama, Pennsylvania

October 1989

Environmental Research Division
Argonne National Laboratory
Argonne, Illinois 60439

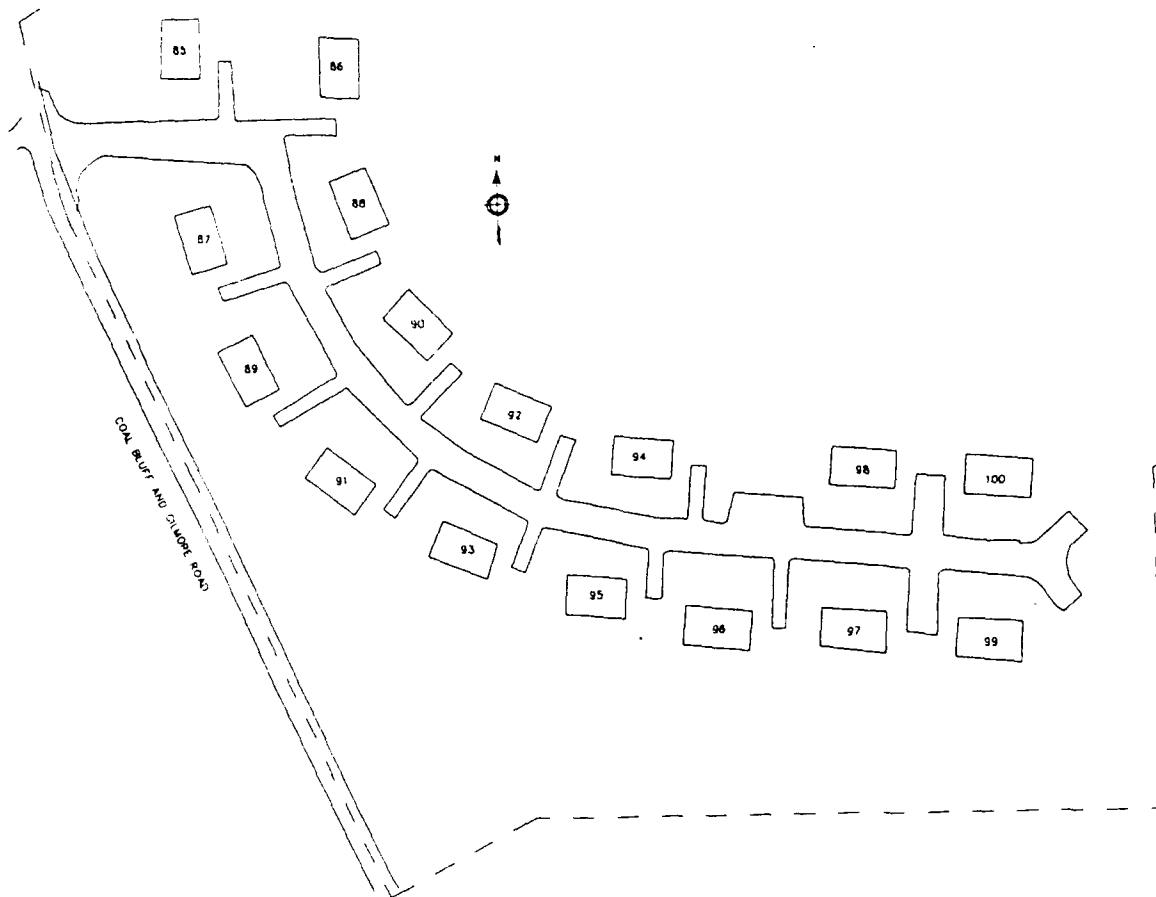
FIGURE 3 Site Plan Map of Elrama Army Housing Units

side of the property. The main sewer line starts from a clean-out hole (located in the front yard of unit #100). The line runs straight west to the first manhole (located at the front yard between housing units #91 and 93), then to a second manhole (located at the east side of unit #85), and finally northeastward to the treatment plant.⁵ The sewage treatment plant is of the trickle-down type, located down a slope at the northern part of the area. This sewage treatment facility has always served only the housing area. No wastes from the operating areas of the Nike battery were ever delivered to this plant for treatment. Up until recently, about 5,000 gallons per day of wastewater were released from the plant into the neighboring Peter's Creek after being treated in a trickling-filter system equipped with an Imhoff tank. At present, the trickling-filter apparatus is not functional. However, wastes are still being discharged to Peter's Creek after passage through the filter media and after chlorination. A sewage odor is present. This

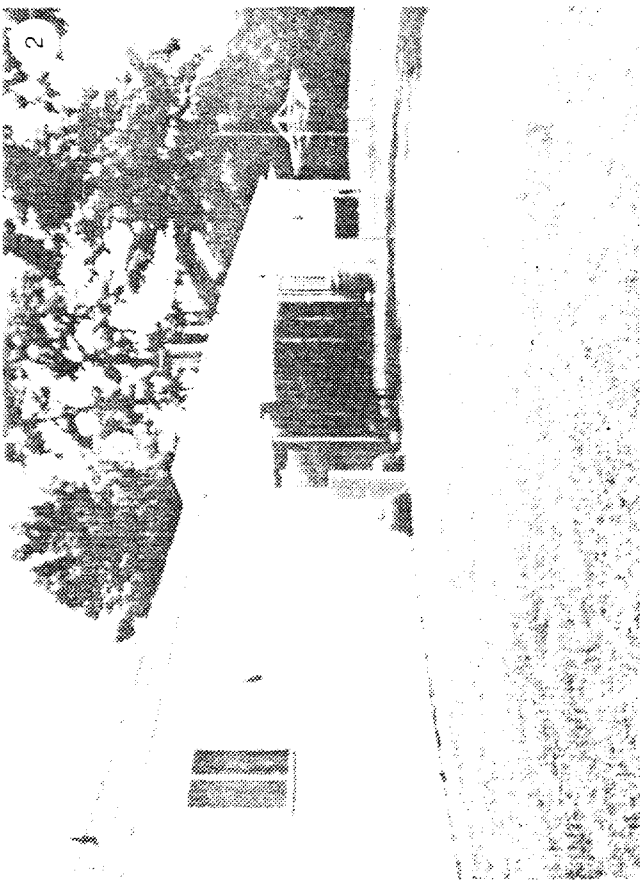
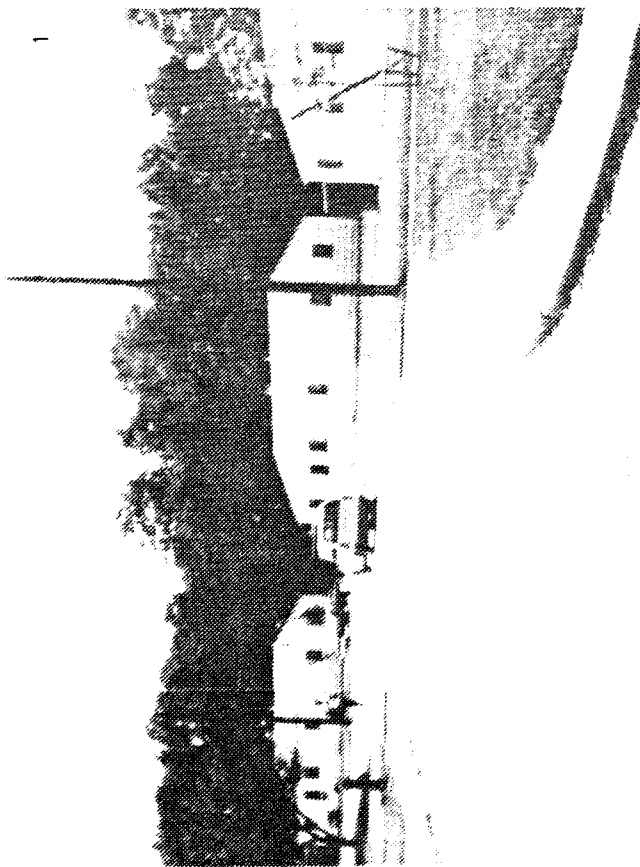
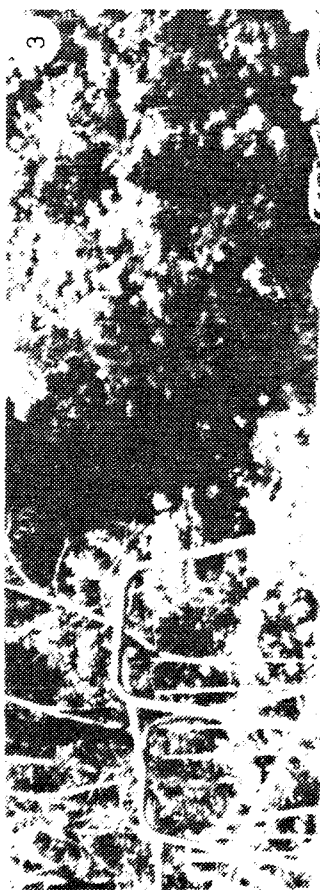
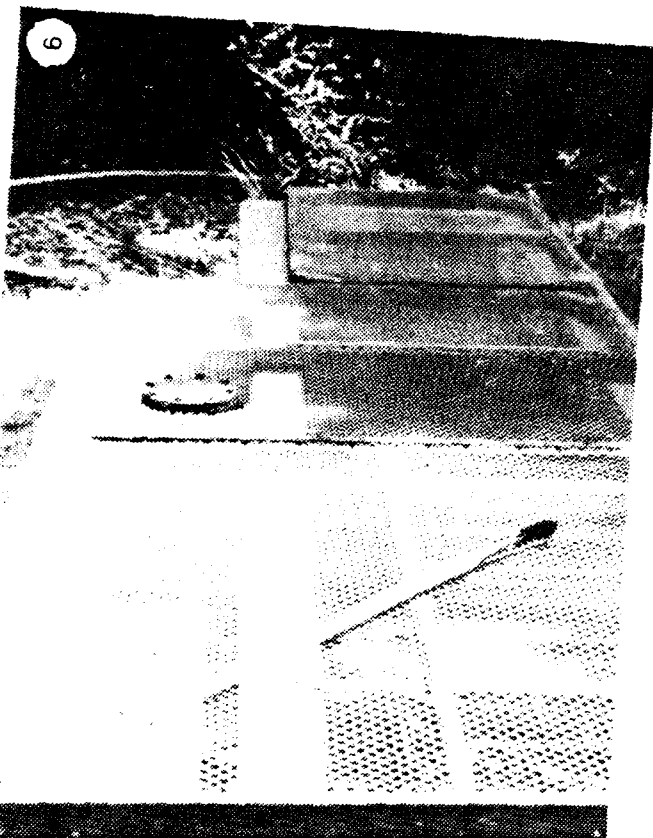
1. A front view of the housing units (southeast direction).
2. Rear area of two housing units.
3. Playground at the housing area.
4. Electrical transformer at top of a utility pole; transformers are the responsibility of the Western Pennsylvania Power Company.
5. Sanitary-sewage treatment building, containing the chlorination unit for wastewater treatment; future plan calls for replacing on-site treatment with services of the township sewage system.
6. The sewage separation system.
7. Rock bed of the trickle filter system for treating sewage.
